Leadwood Mine Tailings Impoundment

Inspection of Leadwood Dam Decant Structure

***Prepared for
The Doe Run Company***

October 2013

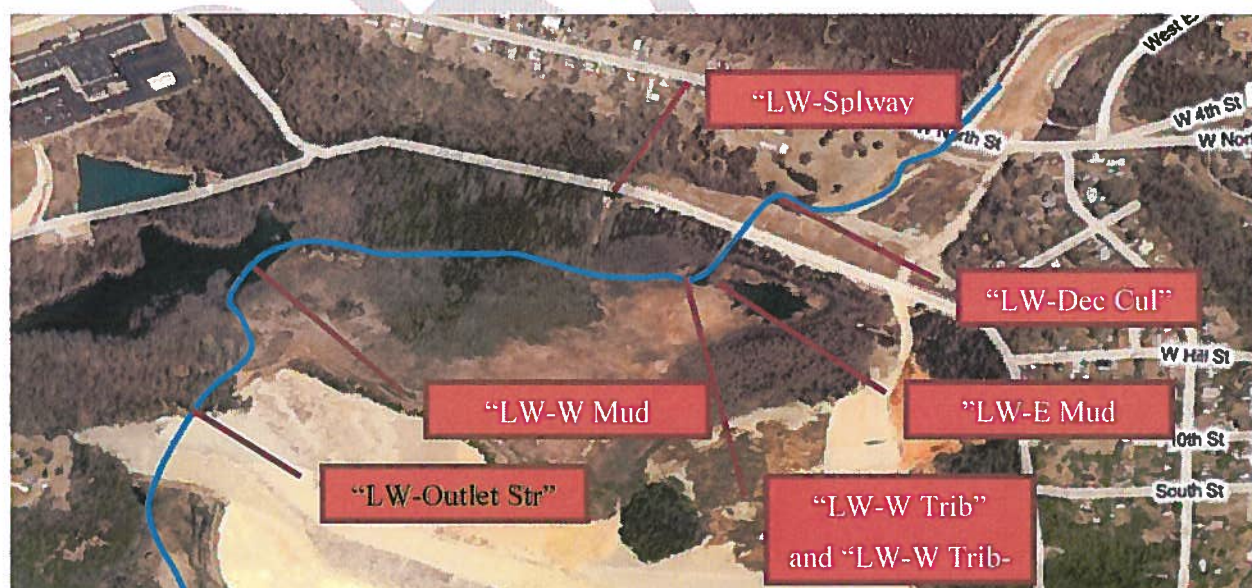
Figure 1 – Sampling locations; "LW-Outlet Str" is upstream of all other sampling locations, while "LW-Dec Cul" is downstream of all other sampling locations

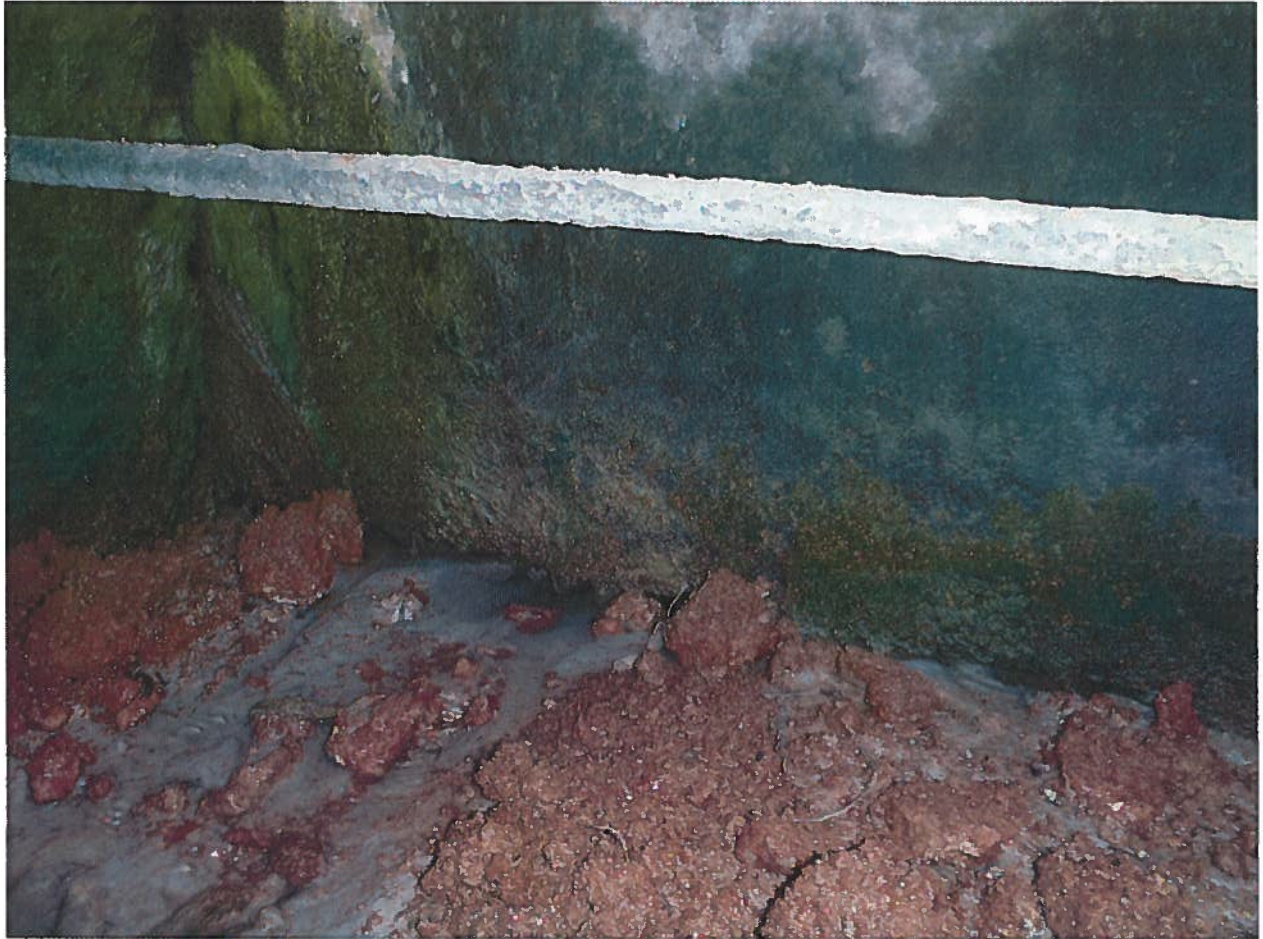
- Approximately 10 feet below the top of concrete on the west wall, there is a concrete bulkhead blocking a 5.5 feet by 7 feet opening in the main shaft wall. A large volume of water has continuously been observed flowing through the bottom seam between the bulkhead and wall opening. The flow rate out of the seam varies based on surface conditions but is estimated to have be as high as 1,000 gallons a minute. During low flow conditions, grey sediment has been observed on the bottom ledge of the opening (See Photographs 1 and 2 in Appendix B).

Photograph 2-Seam at concrete bulkhead, south shaft, looking southwest; red sediment is clay that was used for water control, and was deposited during inspection preparation; gray sediment is assumed to be scouring into the decant structure

- **Abandonment of Decant Tower as Primary Drainage Structure**-This option would entail directing surface flow down the spillway channel rather than through the decant tower. Remediation of the decant tower would be limited to the most problematic locations (such as the seam shown in Photograph 1 in Appendix B), and any remaining seepage into the structure would be collected at the culvert discharge and directed to coincide with seepage water surfacing at the toe of the earthen embankment, where a pump station is currently planned for water treatment/water management purposes. This option would require further analysis of surface hydrology/hydraulics, government regulations pertaining to dams, and evaluation of the spillway channel characteristics.

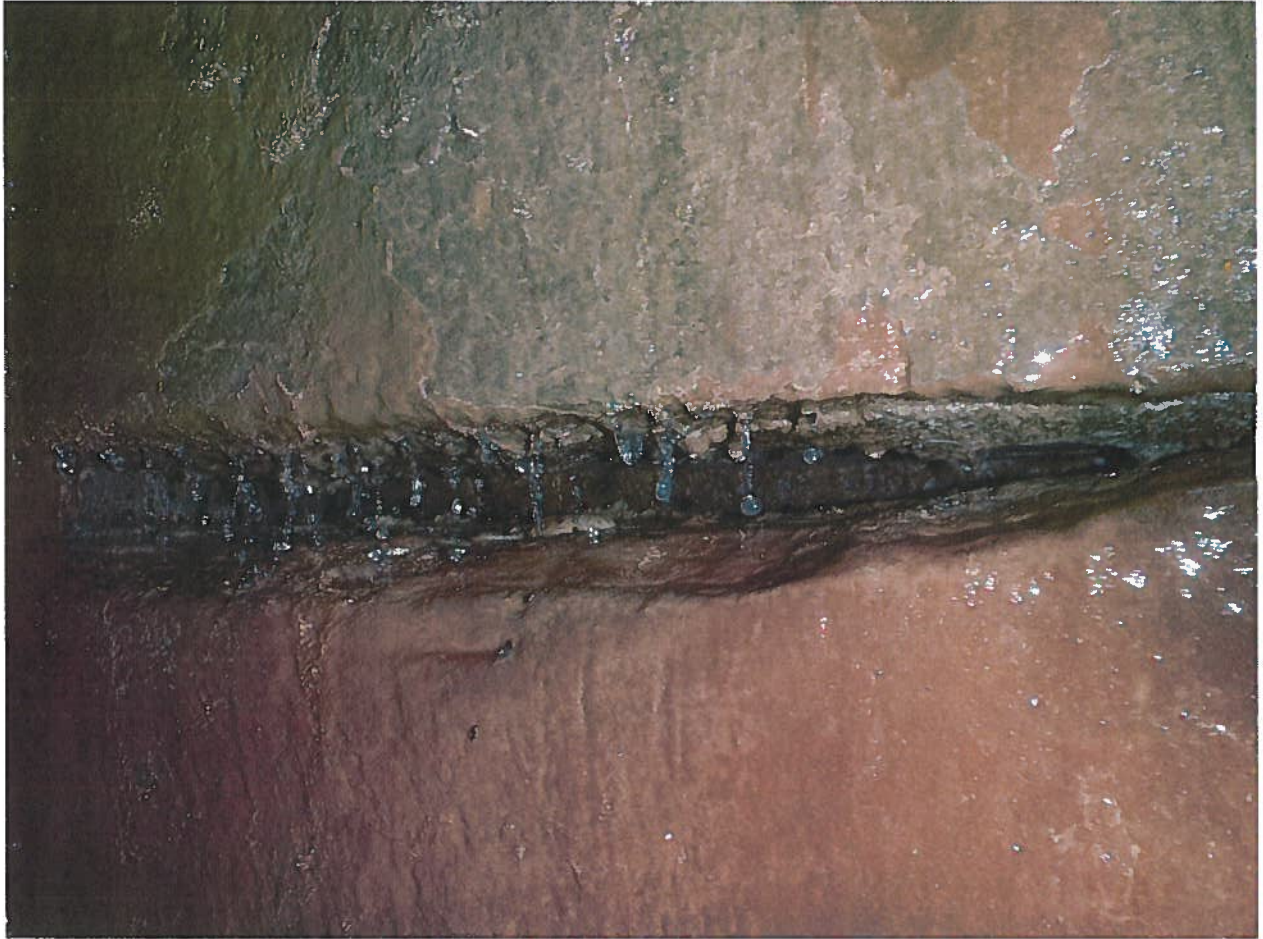
Photograph 4-Large gap at seam, south shaft, looking southwest

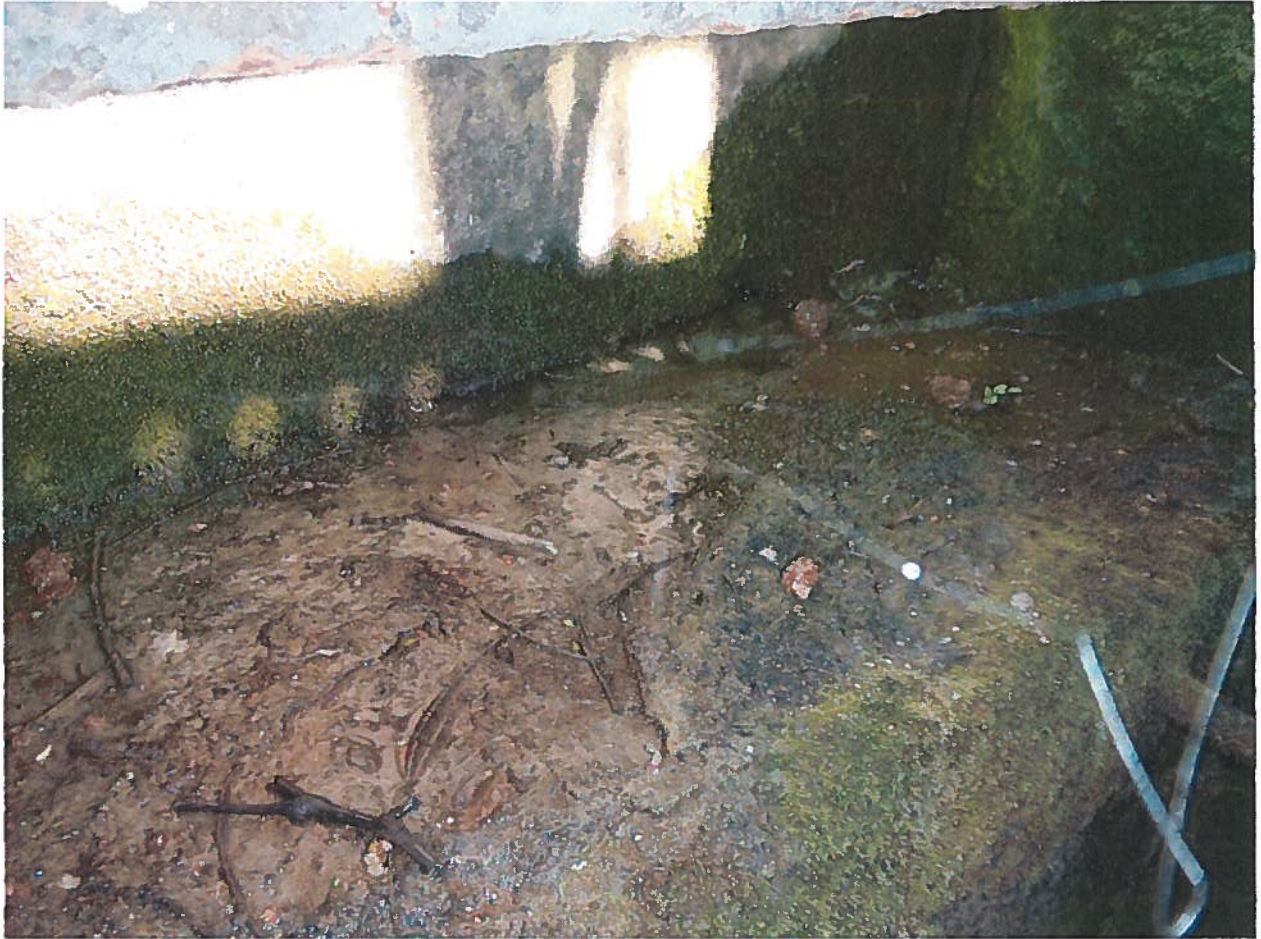
Photograph 6-Bulkhead interface, north shaft, looking northwest

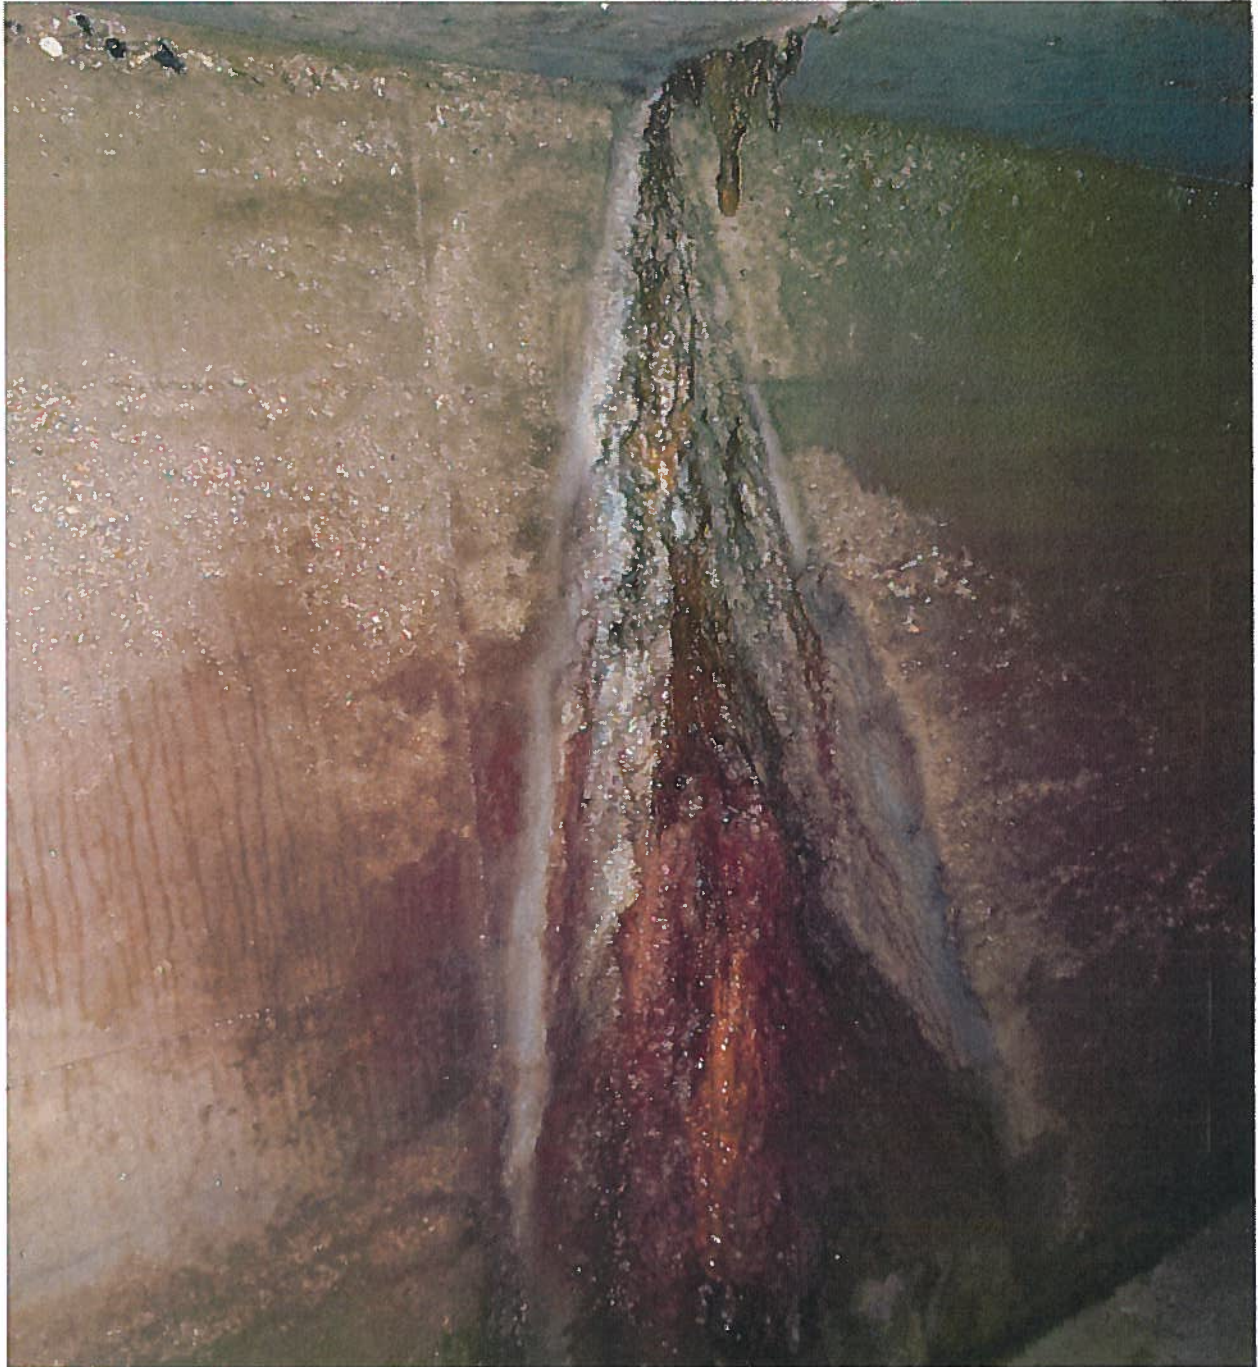
The presence of iron bacteria and darker discoloration was observed approximately 100 lineal feet from the culvert discharge. It continued to be present at seams and cracks through the rest of the length of the culvert leading to the decant tower. The mineralization varied from surface discoloration to formations that protruded as much as 6 inches from the concrete surface and formed stalactites from seams and fissures in the culvert ceiling (See Photograph 9 in Appendix B).

Photograph 9-Mineralization (iron oxidation and efflorescence) in culvert, approximately 450 lineal feet from culvert discharge, looking southeast
